CDF Operations

- Store Summary
- Access Work
- Modifying FTMs
- Summary

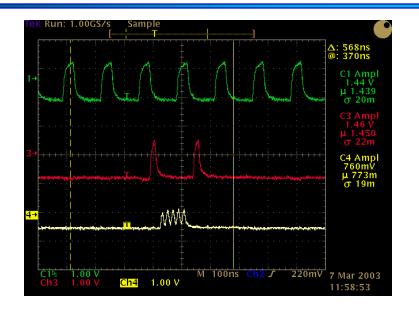
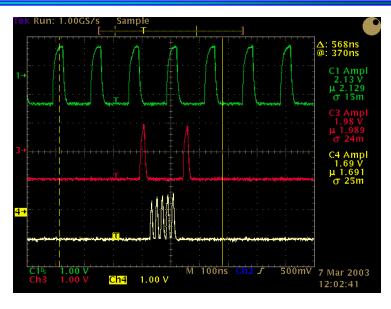
FTM Signals

- FTMs are transition modules for Fiber Interface Boards
- 11 of 12 wire bond failures on the Silicon Detector have been due to high occupancy caused by
 - Receiving a 5th level 1 accept
 - Missing the control signal (PRD2) free a level 1 buffer
 - Missing the clock edge to latch the PRD2 signal
- Differential transmission lines for these signals are driven by chips on the FTM whose output is controlled by resistors and jumpers
- The problem has been observed and fixed in a teststand by buffing the output of the driver chips

- Unbuffed and buffed control signals
- In last 8 weeks, no problems on modified FTMs
- There are 33 of 58 FTMs which still need to be modified
- Plan to take advantage of any access opportunity >1.5h
 - 1 hour of overhead and checkout
 - 15 mins to modify each board
